**Flightdeck Party Line Issues:
An Aviation Safety Reporting
System Analysis**

June 1995

DOT/FAA/CT-TN95/12

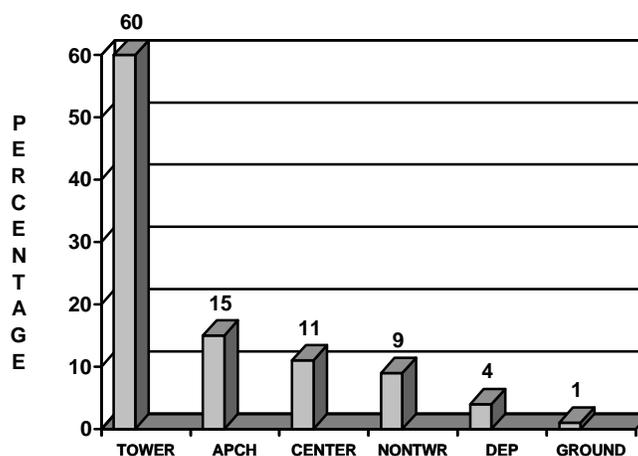
FIGURE 1. CONTROLLING AGENCY

Figure 1 shows the distribution of controlling agencies involved in the reports. Sixty percent of the incidents reported party line transmissions over the tower frequency. The tower controller's (or local controller's) responsibility is for operations on the active runway for both departing and arriving traffic.

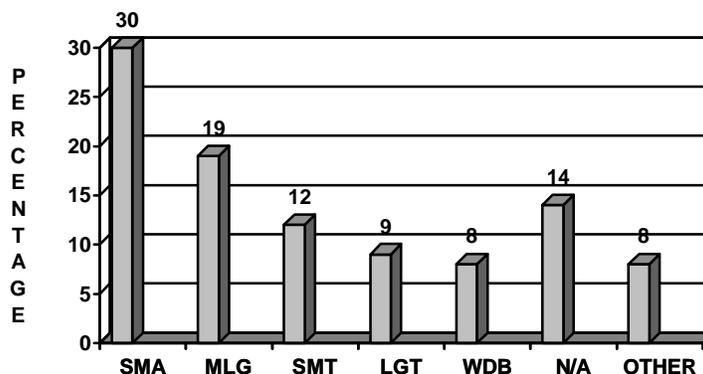
FIGURE 2. TYPE OF AIRCRAFT

Figure 2 portrays, in order of occurrence, the various types of aircraft involved in the incidents. Note: The aircraft of both the listener and the receiver of the party line information were counted in the data. The majority of aircraft involved in the incidents were Small Aircraft (SMA) (30 percent) flying under Visual Flight Rule (VFR) conditions.

The rest, in order of their occurrence: Medium Large Transport (MLG) (19 percent), Small Transport (SMT) (12 percent), Large Transport (LGT) (9 percent), Wide Body (WDB) (8 percent) and Other (8 percent). Fourteen percent of the aircraft were unable to be determined from the report.

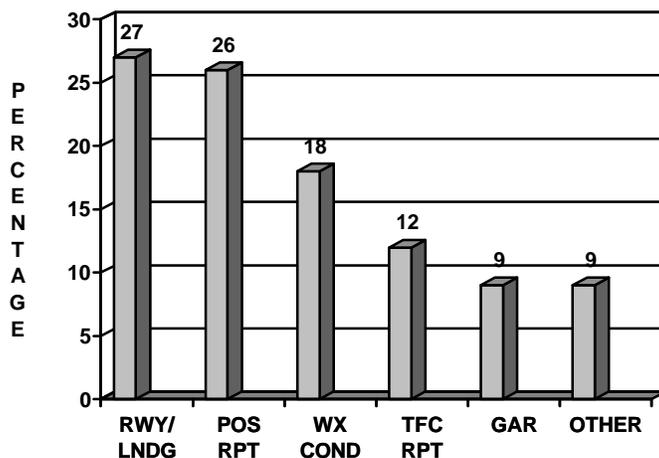
FIGURE 3. ADVISORY PLI ELEMENTS

Figure 3 depicts the distribution of the advisory PLI elements found in the reports. The breakdown is as follows: Runway/Landing Intentions (27 percent), Position Report (25 percent), Weather Information/Conditions (18 percent), Traffic Reports (12 percent), Go-around Intentions (9 percent) and Other (9 percent). Traffic reports were considered separate and distinct from position reports as they were information conveyed by air traffic control; position reports were conveyed by flight crews.

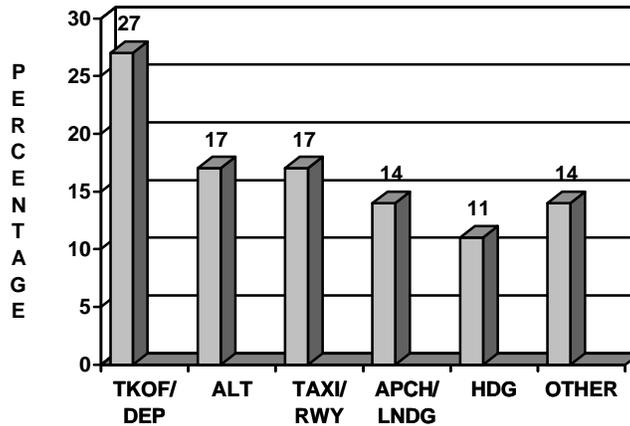
FIGURE 4. INSTRUCTIONAL PLI ELEMENTS

Figure 4 depicts the distribution of the instructional PLI elements. The breakdown is as follows: Takeoff/Departure Clearances (27 percent), Altitude Clearances (17 percent), Taxi/Runway Clearances (17 percent), Approach/Landing Clearances (14 percent), Heading/Vector Clearances (11 percent) and Other (14 percent). The other category contained less prevalent elements such as information regarding missed approaches, touch and goes, holdings, etc. Three of the top four categories involved operations at or near the airport surface; this again,

portrays the prevalence of party line information in the terminal environment.

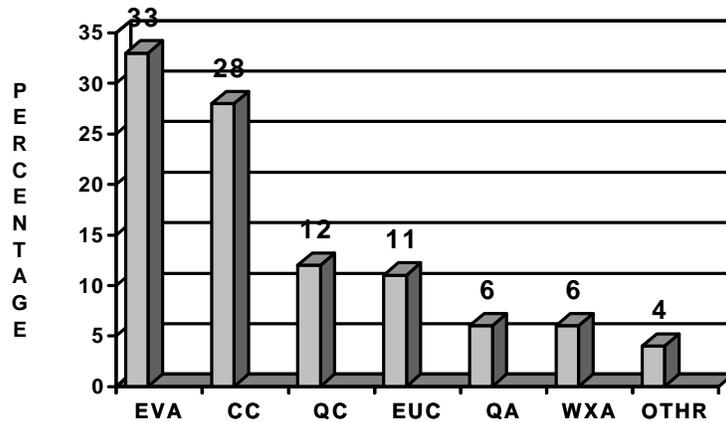
FIGURE 5. LISTENER ACTIONS

Figure 5 provides a distribution of the listener actions that were based on the party line. The following actions were identified: Evasive Action (EVA) (33 percent), Continued Clearance (CC) (28 percent), Query Controller (QC) (12 percent), Executed Unauthorized Clearance (EUC) (11 percent), Query Aircraft (QA) (6 percent), Weather Awareness/Avoidance (WXA) (6 percent) and Other (OTHR) (4 percent). Actions that were not as prevalent (e.g., request clearance, programming of the FMS) were combined into the Other category.

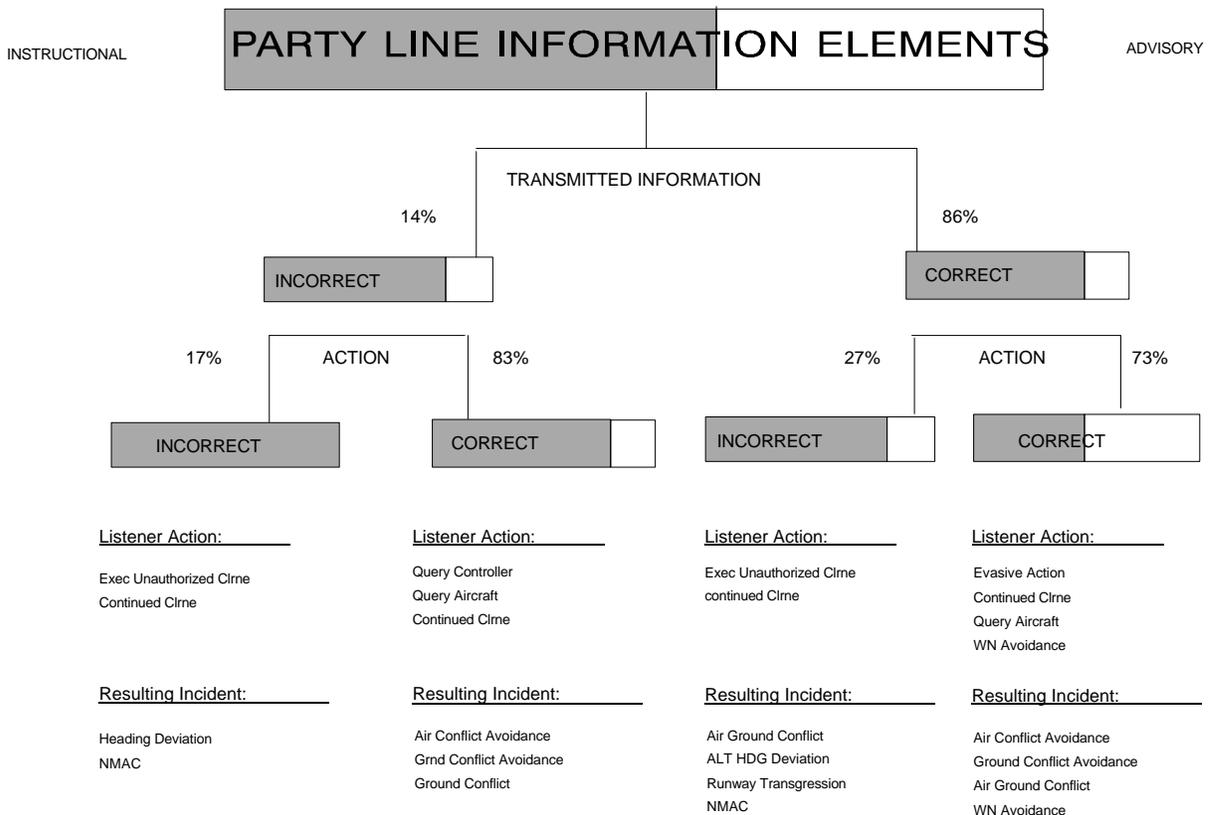
FIGURE 6. ERROR ANALYSIS TREE

The discussion that follows expands on the previous sections by showing how all the information is related to one another. This was accomplished through an error analysis; taking each component of the party line, from the transmission of the information to the actions performed by the flight crews and determining where the problems lie. The results of this analysis are depicted in the error analysis tree shown in figure 6.

There are two different kinds of errors that are directly attributed to the information conveyed over the party line. They are as follows: (1) errors attributed to incorrect transmission (first level branch); and (2) errors resulting from incorrect actions by the flight crews (second level branch).

The numbers along the branches (outside the boxed areas) are percentages of the various conditions. For example, 14 percent of the PLI elements were transmitted incorrectly. Continuing down the same branch, 17 percent (of the incorrect transmissions) resulted in an incorrect listener action and 83 percent resulted in a correct listener action. The shaded area within the boxes represents the percentage of instructional PLI elements and the nonshaded area represents the advisory PLI elements.

What unfolds on the second level branch then, are four separate error categories, from left to right: (1) Incorrect Transmission, Incorrect Action (II); (2) Incorrect Transmission, Correct Action (IC); (3) Correct Transmission, Incorrect Action (CI); and (4) Correct Transmission, Correct Action (CC). Table 7 provides the number of occurrences and overall percentages for each condition. The percentages are based on the entire list of 85 individual PL elements used in the analysis.
